LAKE NELSON DAM

NJ 00376

6 PHASE 1 INSPECTION REPORT  
NATIONAL DAM SAFETY PROGRAM.

Lake Nelson Dam (NJ 00376). Raritan River  
Basin, Ambrose Brook, Middlesex County,  
New Jersey. Phase 1 Inspection Report.

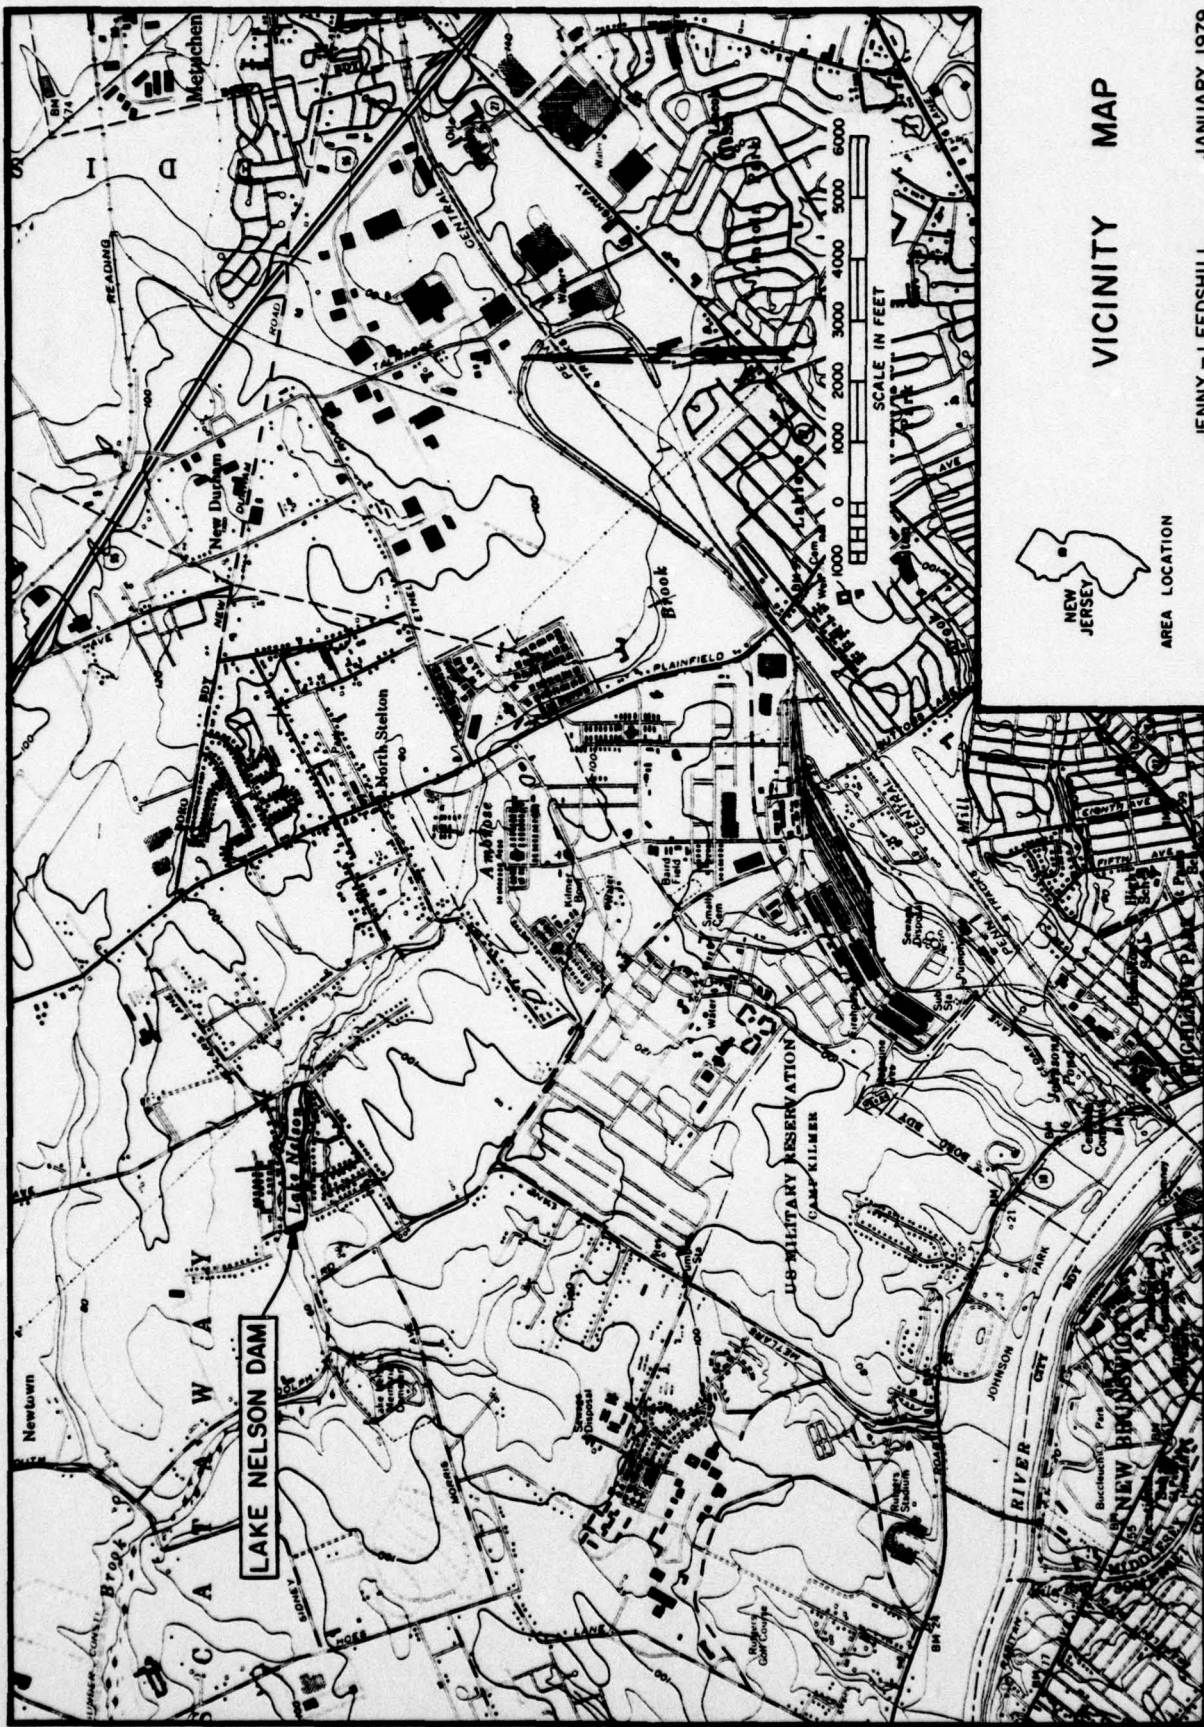
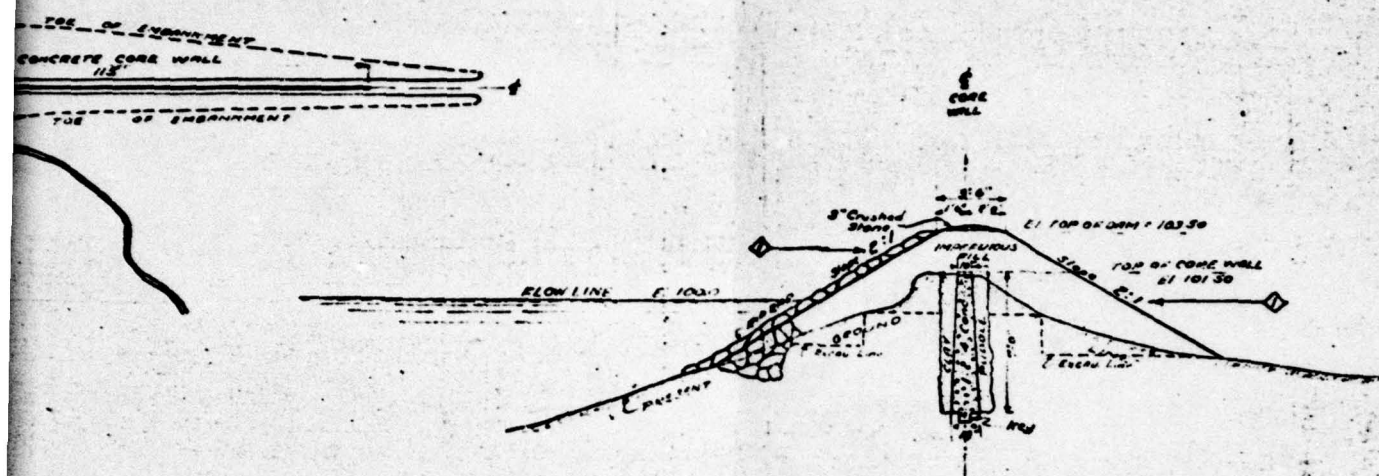
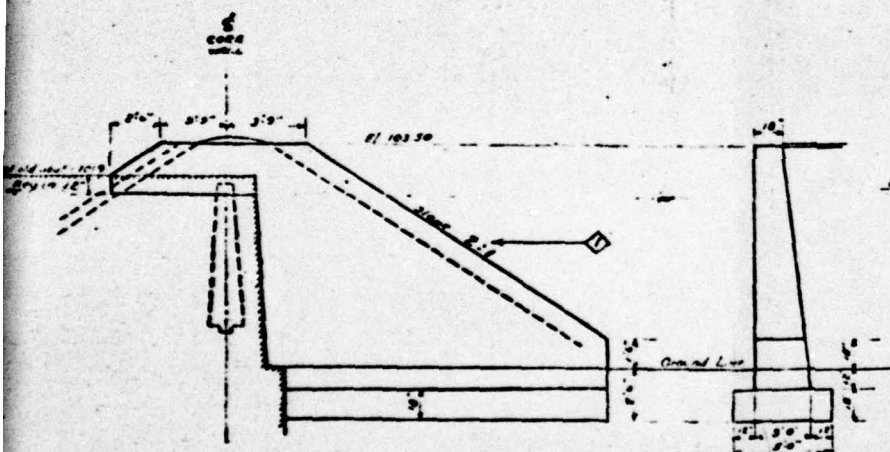
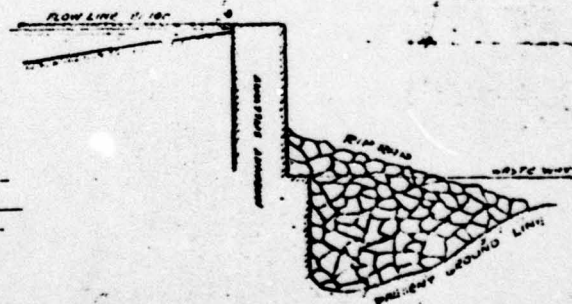
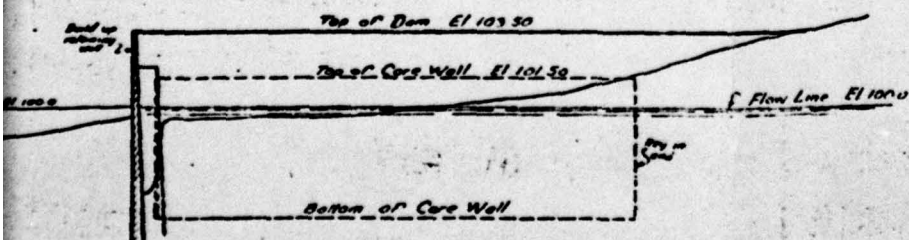
PROPOSED RECONSTRUCTION  
OF  
LAKE NELSON DAM  
AT  
NEW MARKET, N.J.  
OCT. 1, 1936 SCALE 1"=50'

Visual inspection indicates that the existing dam differs somewhat from that shown in Plate 2. This drawing indicates that the top of the embankment was to be raised to the top of the spillway wing walls; however, the top of the dam is presently approximately 1.5 feet below the top of the wing walls, possibly due to subsequent erosion. The present configuration of the spillway discharge channel is not as shown on Plate 2, and a concrete wall has been added at the upstream side of the north embankment. In addition, the spillway buttresses and apron and the emergency spillway are not shown on Plate 2. A sketch of the present configuration of the general spillway area based on visual inspection is shown on Plate 3.

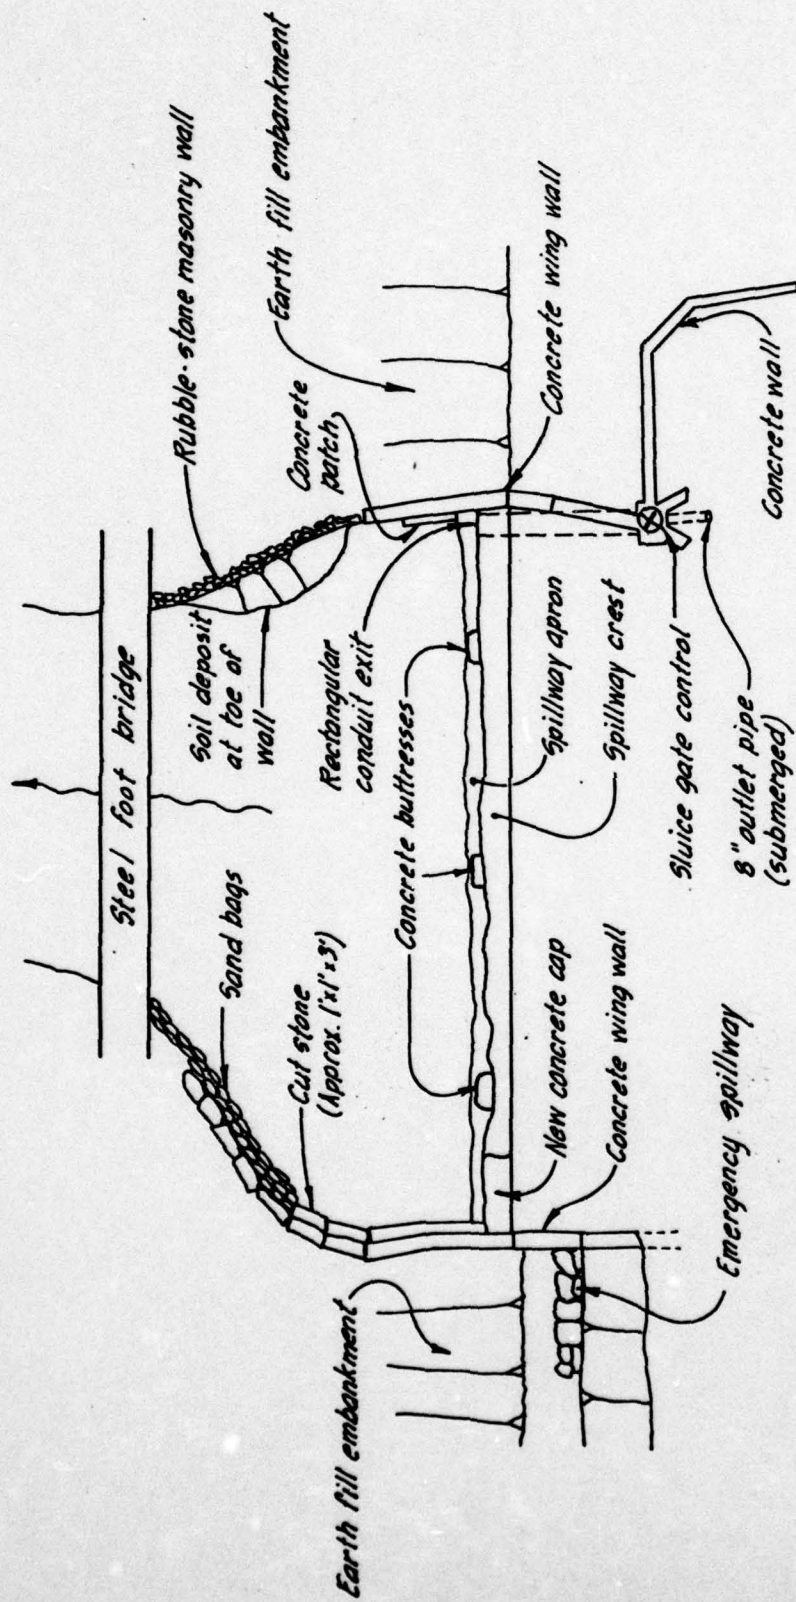
A concrete retaining wall protects the upstream side of the embankment north of the spillway (Plate 3 and Overview Photo). This section of the embankment is covered with trees and grass and appears to be in satisfactory condition. The embankment in this area is in the backyard of a house, the owner of which (Mr. Komanski) reported several instances of dam overtopping which flooded his basement and endangered the foundation of his house.

The discharge over the spillway falls into a pool at the base of the weir. The water depth in the pool was 0.5 to 1 foot during the inspection. A few of the cut stones which line the south embankment of the pool have been dislodged, but the sandbag lining of the southern edge appears to be in good condition. The rubble masonry wall which lines the north embankment of the pool appears to be in satisfactory condition. A soil deposit is present at the toe of this wall (Plate 3 and Photo 9).
